12.0 AERIAL PHOTOGRAPH REVIEW

Appendix C contains a series of aerial photographs of the HMSC facility and surrounding land. Photos from 1952, 1960, 1963, 1965, 1968, 1976 and 1992 are included. The photos are described below, in chronological order.

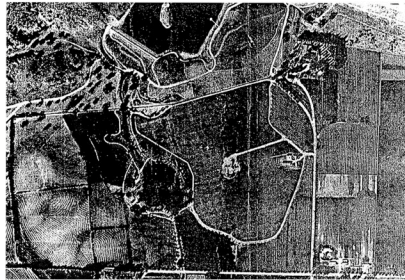
November 3, 1952

In 1952 the subject site was farmland. The knoll later to become the research facility is clearly visible at the center of the photo, outlined by a curved dirt road. A house or other building is at the top of the knoll. The Chatsworth dam and reservoir, in service, are visible north of the site. Hidden Lake (apparently called Lees Lake before renaming by developers) is to the west. The lake appears to have been created by construction of a small earth dam across Chatsworth Creek. The creek is visible between the Chatsworth reservoir and the lake, and again below the lake. Orchards and fields lie west of the lake. Fields lie south and east of the site. Fallbrook Avenue and Roscoe Boulevard, or their forerunners, are in existence, but appear to be dirt roads. No residential neighborhoods or non-farming industries are visible.

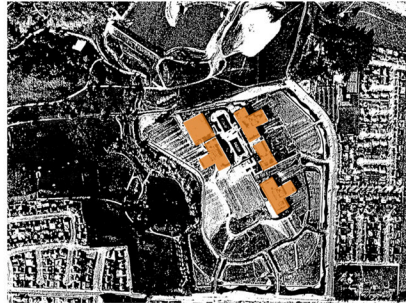
November 27, 1965

Again, only minor change is apparent from the previous photo. The small Building 271 has appeared between buildings 262 and 263. Small objects are visible just east of Building 272; these are likely the miscellaneous drums described by McLaren-Hart in their report. It is apparently a weekend day; only scattered cars are present in the parking areas.

Off-site areas are little changed. Levels in the reservoir and in Lees/Hidden Lake are low.

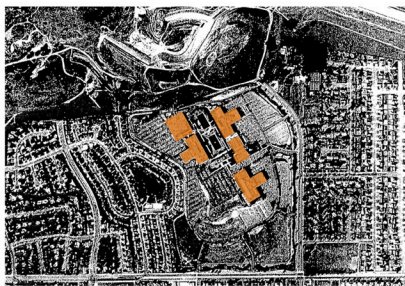
February 25, 1976

The site shows no significant changes. North of the site, the Chatsworth reservoir has now been drained. West of the site, the Hidden Lake housing development is complete. At the eastern edge of the photo, other new residences are visible.
