**Comments on the Group 7 RCRA Facility Investigation (RFI)**

**4/1/2010**

ACME (Aerospace Cancer Museum of Education) has provided the below comments for the Group 7 Resource Conservation and Recovery Act (RCRA) Facility Investigation Report of the Santa Susana Field Laboratory (SSFL) AREA IV portion. This was/is primarily Nuclear Research/Storage Areas, yet many chemicals were associated with operations. Trichloroethylene (TCE) has been a site-wide issue and from the illustration below indicates a Group 7 issue as well. This is a major concern (aside from the radionuclide contamination) as it drains into the American Jewish University’s Brandeis-Bardin Campus, releasing into the Arroyo Simi and eventually the ocean. The majority of the surface drainage of the SSFL drains into the Los Angeles River via Bell Creek, yet this reporting area is the 257 acre portion of the 2850 acres that drain onto the Simi Valley side of “The Hill” [http://www.rocketdynearchives.com/images/The\\_Hill\\_brochure\\_rocketdyne\\_archives\\_boeing\\_ssfl\\_santa\\_susana\\_field\\_lab\\_nuclear\\_laboratory.pdf](http://www.rocketdynearchives.com/images/The_Hill_brochure_rocketdyne_archives_boeing_ssfl_

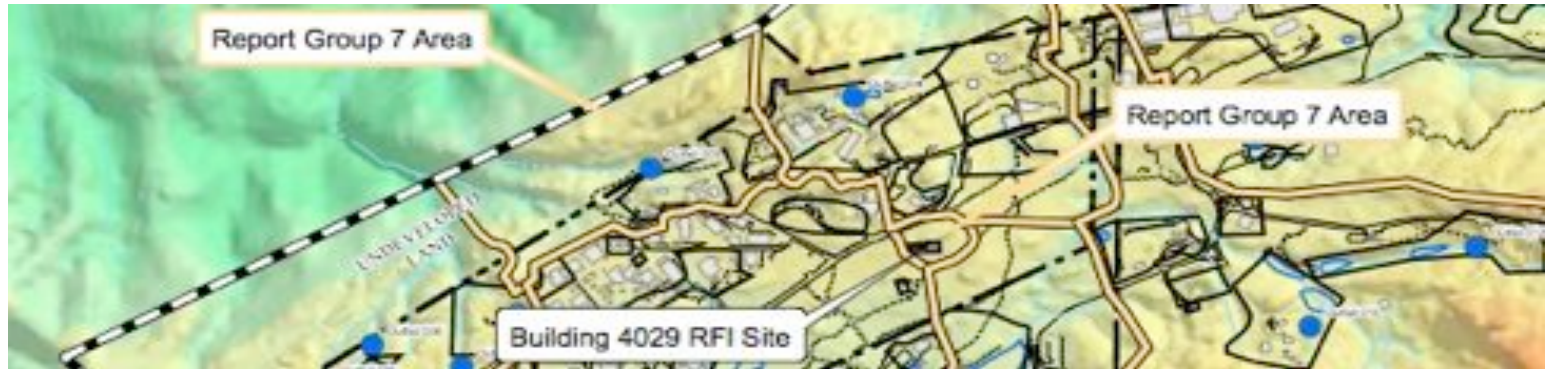
A major concern that sticks out like a sore thumb is the separate circle of Group 7 that surrounds Building 4029. These RFI areas were divided up into surface water drainage...

...areas and are all included together, except this one. It is almost like this facility was of a great concern and they came back to it lumping into a non-associated grouping. According the Facilities Engineering Map created in 1984 by R.K. Boyles for Rockwell International, it indicates this building was/is to be used for Hazardous Waste Storage...

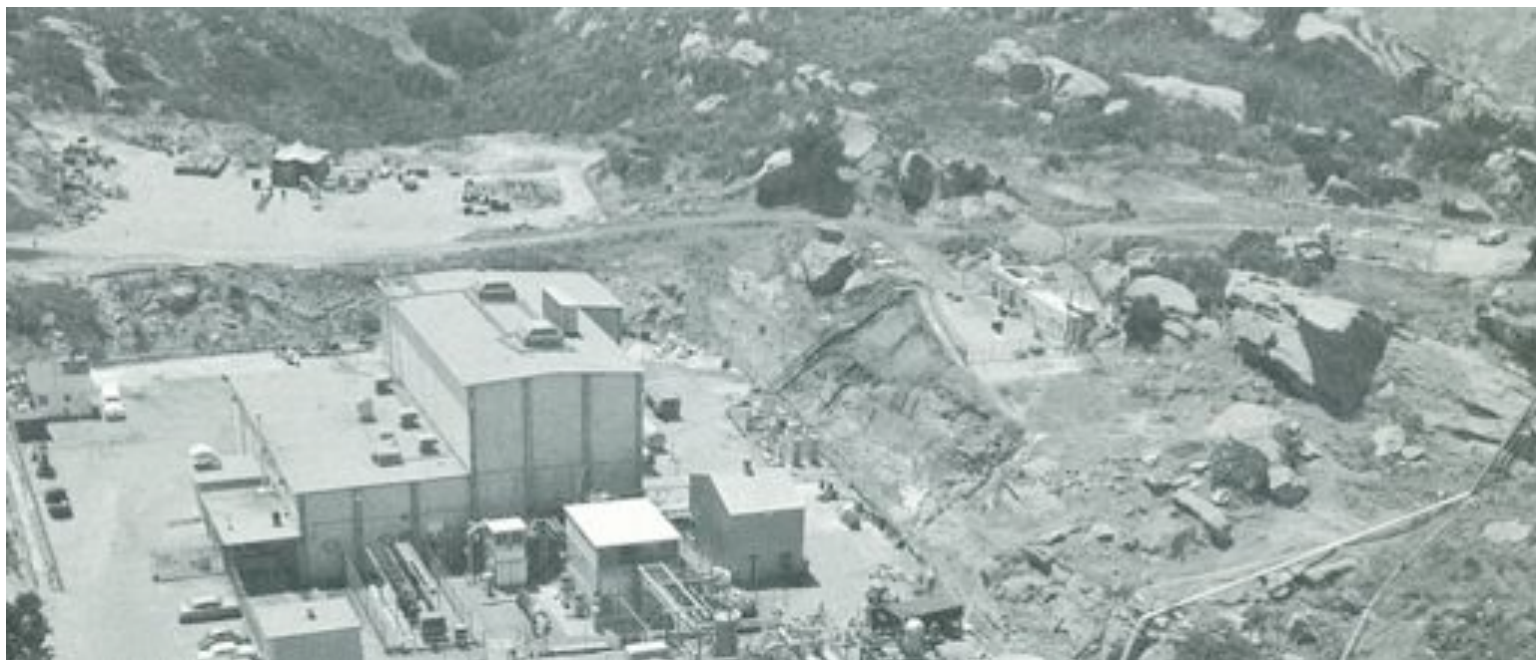
The above photo shows the location of Building 4133 prior to construction. This area is located just above the SRE and it appears a "Tent" is used possibly for an office to log in some of the hazardous waste that you see in the form of 55 Gallon Drums surrounding this "Tent". This entire area needs to be looked into, as it is a very different scene than we are used to in the present (See Photo Below: Building 4133 in 2008).

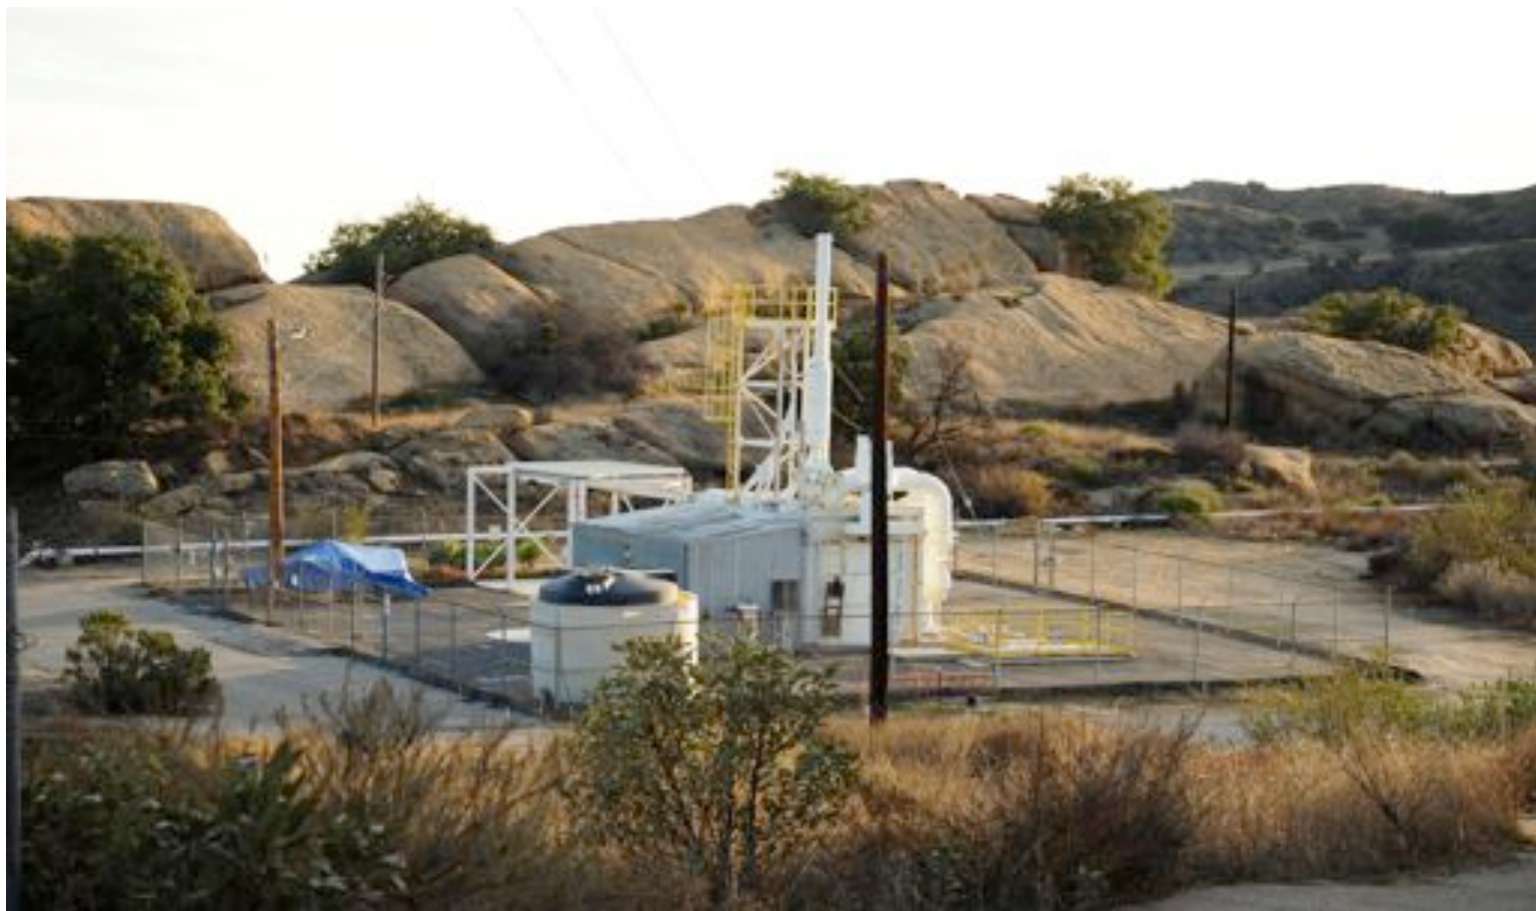
From former employee interviews the Building 4133 was used as a Sodium Burn Facility so aside from the traces of Sodium found there should be careful screening of all types of Dioxins that are associated with Sodium Incineration. From other reports I have read there is a large Mercury contamination problem around this facility and should be addressed as well. We do not want to see any traces of chemicals that could impact the surrounding communities and endanger the health and safety of its residents.

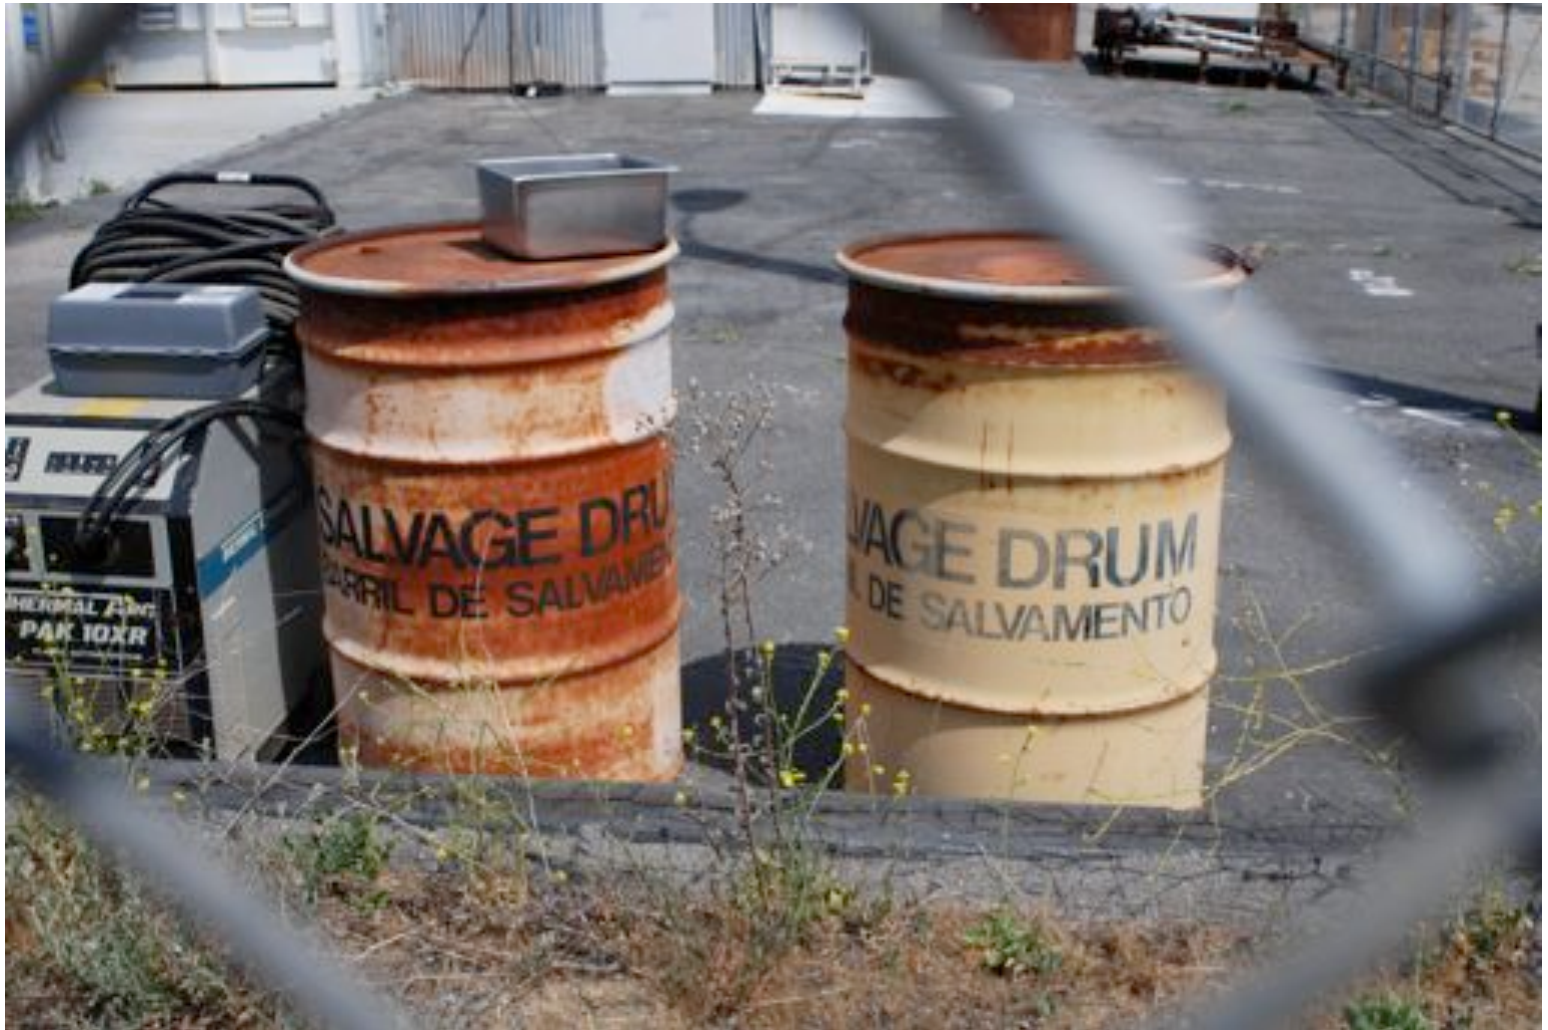
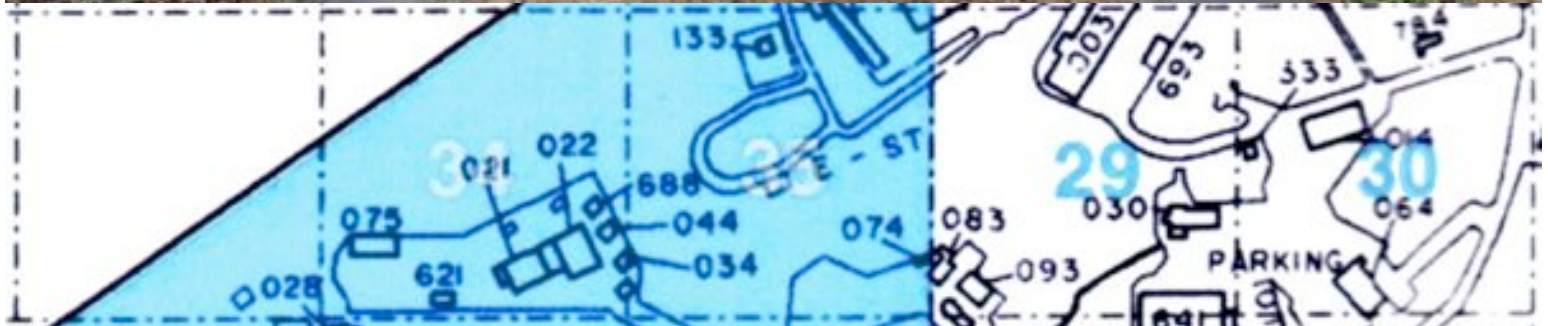
Below we see 55 Gallon Salvage Drums of an unknown substance located on the Southeast corner within the gates of the 4133 Facility. This should be noted to Ensure a Proper Cleanup.

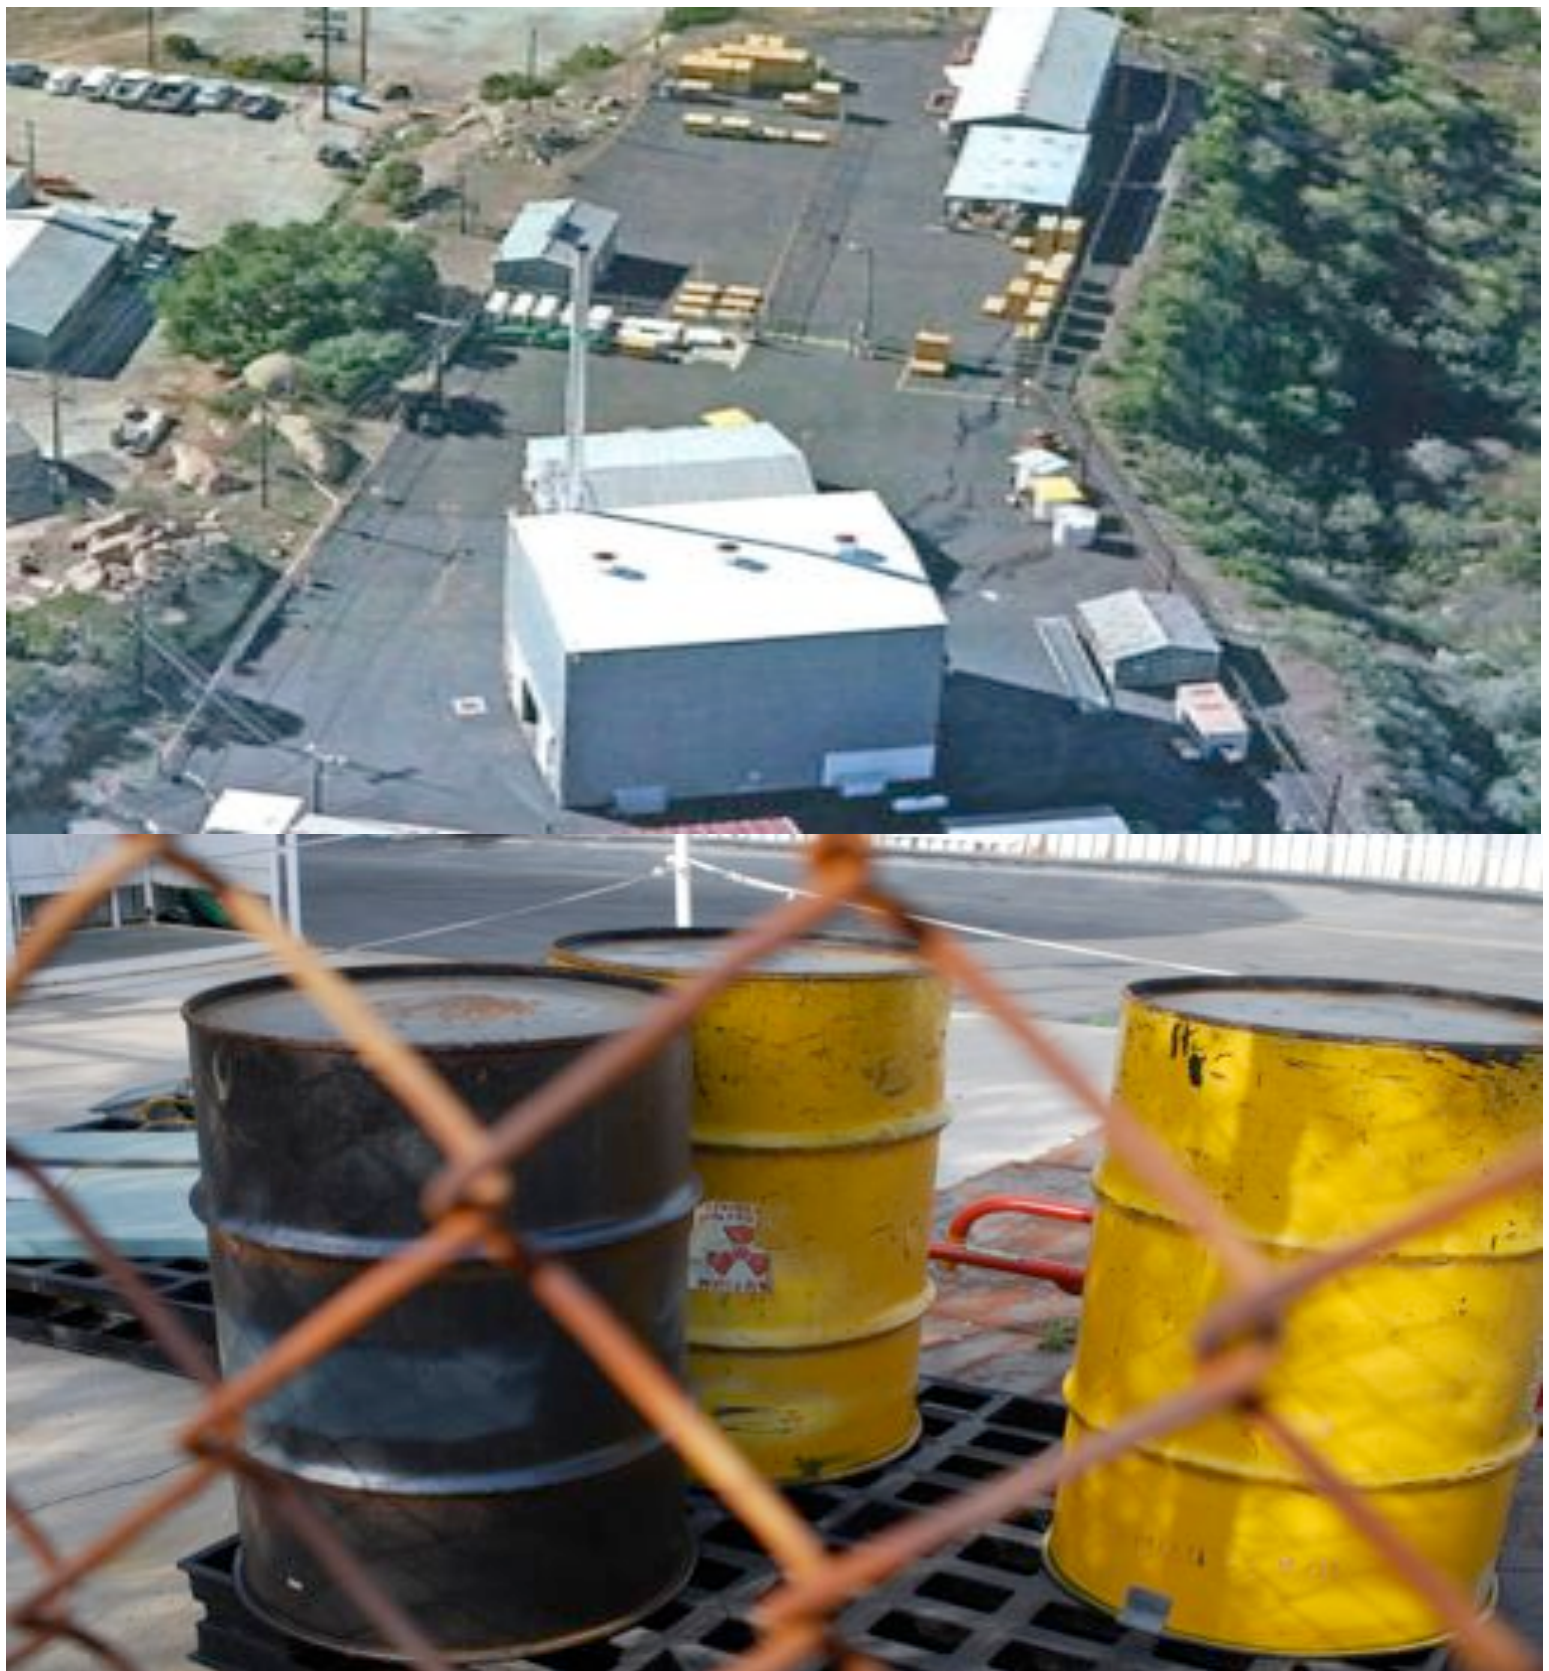
This also brings me to another issue regarding the pavement of the RMHF. Take a look at the photo on the next page, an Aerial shot of the RMHF pulled off the Department of Energy ETEC website. It shows new asphalt pavement and in the 2 years the SSFL has been open to ACME for private tours it has been paved over twice. I have heard from two sources that inform ACME that was/is to keep the radiation levels intact or hidden in the asphalt. If this is the case, when it comes time for the demolition of this ground cover it should be treated as Radioactive and Chemical Waste. With the illustration of TCE findings in this area one would have to concur that the asphalt is contaminated with TCE somewhere in the Dozens of layers unseen from the surface. TCE can disintegrate asphalt into a "Goo" and there could be some areas in this pavement that TCE has broken through the barrier and into the soil and/or groundwater. Please consider this scenario.

The above photo shows 55 Gallon Drums without lids (Black Drum Un-Marked) that are left outside upside down to drip-dry their contents. This is an area that is located on the Northeast corner of the Radioactive Materials Handling Facility and should be sampled extensively to Ensure a Proper Cleanup.

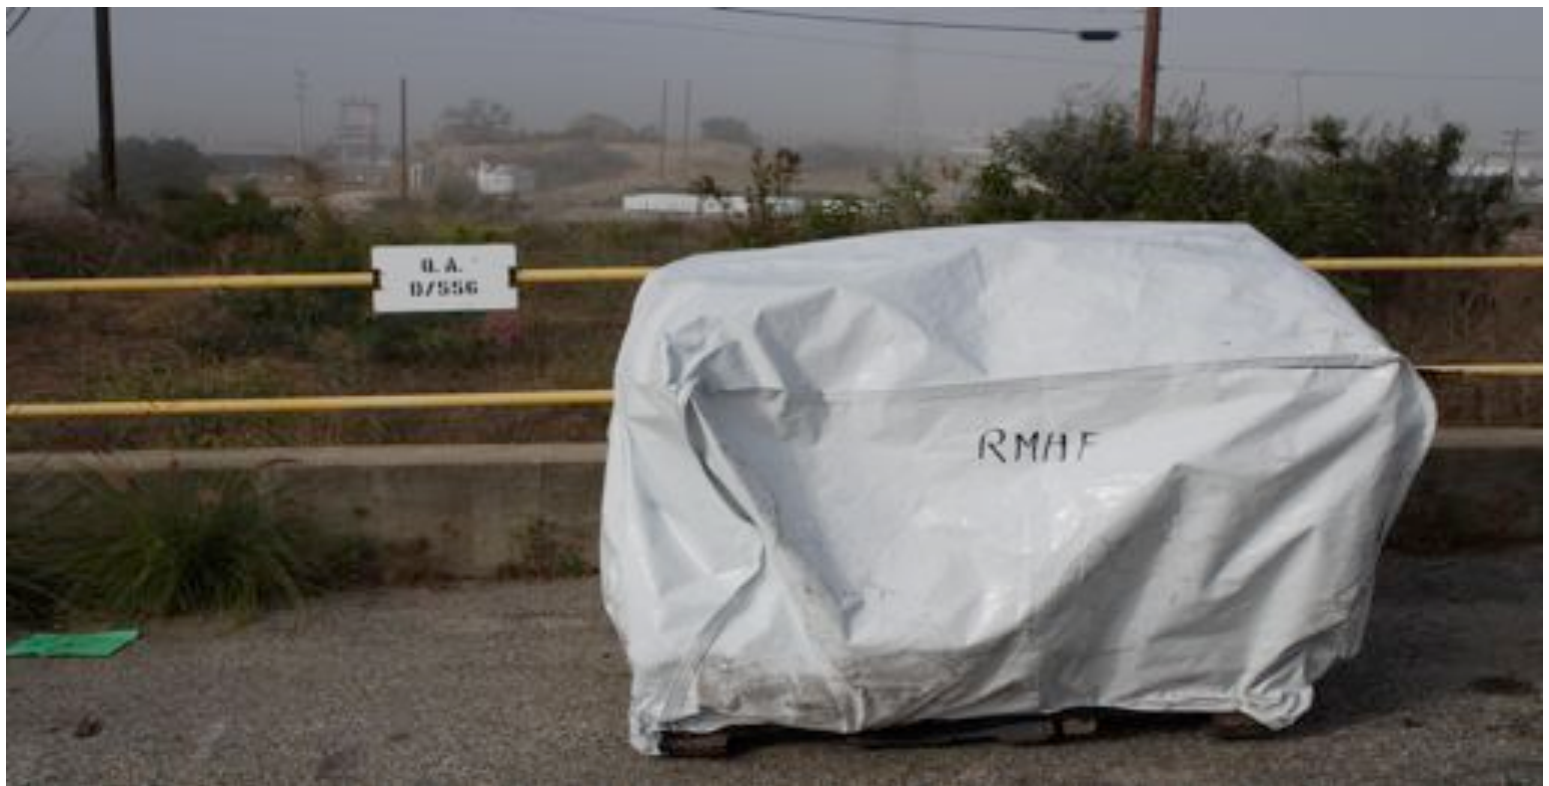
The above photo shows waste from the RMHF sitting on the Roadway outside the RMHF just above former Building 4036. This roadway should be looked into as a potential source of Chemical and Radioactive Contamination and addressed properly. We need to ensure public health and safety by additional sampling, re-working/re-writing the entire Group 7 RFI Report with the help of comments from former employees who need to be contacted for their comments. The company records should be located and ask these former employees of these facilities what they remember and request that any No Further Action determinations be reconsidered. Every single inch of this site needs to be characterized as it sits above several communities and has the potential to risk one's health every time it rains or the wind blows.
