Fact Sheet, November 2008

Santa Susana Field Laboratory Area I Burn Pit Investigation

Radium discovered during sampling

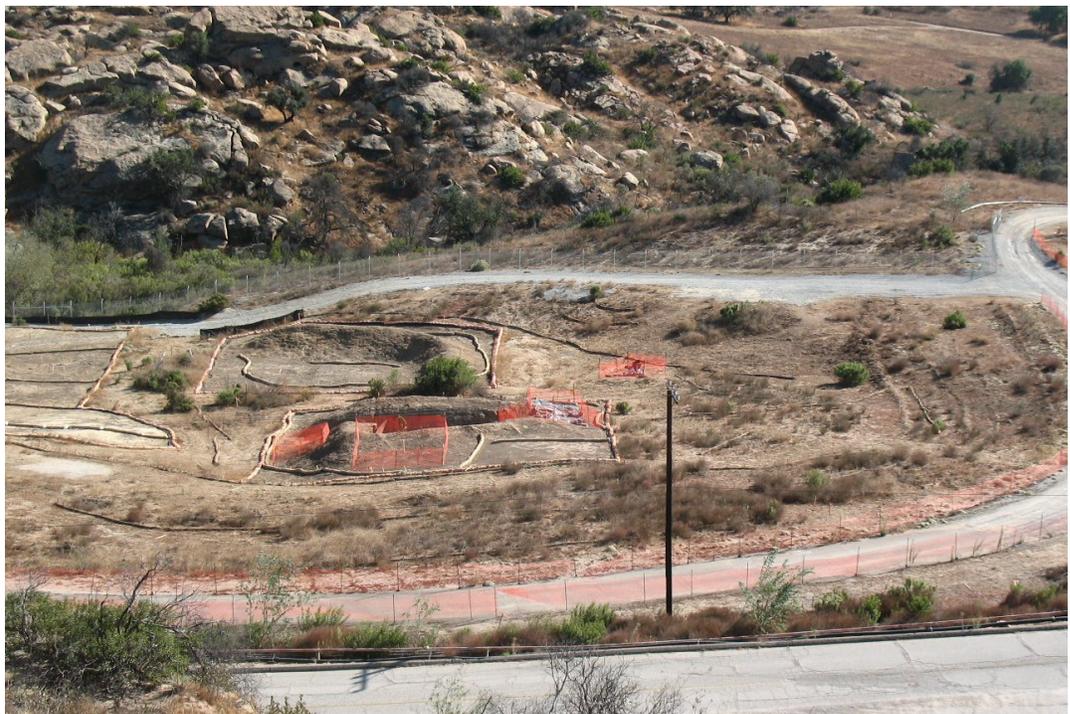
Area I Burn Pit where radium has been detected in soils

The radiation levels, found at nine localized areas and measuring several inches to one foot in diameter, ranged from 20 to 115 microrems per hour. Natural background level is 12 microrems per hour. Within several feet of the impacted soils, radium levels decreased to background levels.

Because this area is not accessible, DTSC does not believe the public is at risk. In addition, Boeing has fenced and posted signs in the areas where the elevated levels were found. Boeing plans to stabilize the area with erosion control and tarping to prevent sediment movement down the drainage until the investigation is complete and the area is cleaned up.
