Santa Susana Field Laboratory

The Use of Trichloroethylene at NASA's SSFL Sites

This provides information on the cleanup of NASA properties at the Santa Susana Field Laboratory (SSFL).

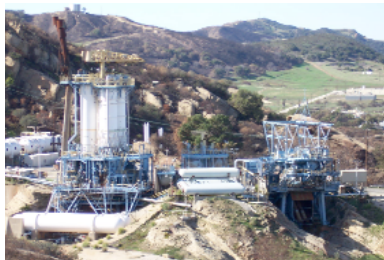
The Bravo Test Stands (including those pictured above) were among four areas NASA used for testing rocket engines.

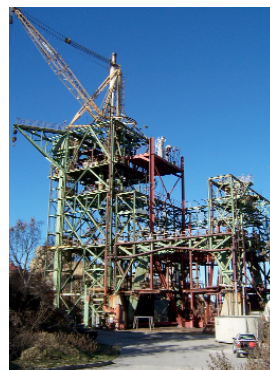
Coca Test Stand #4 was used during Space Shuttle Main Engine testing.

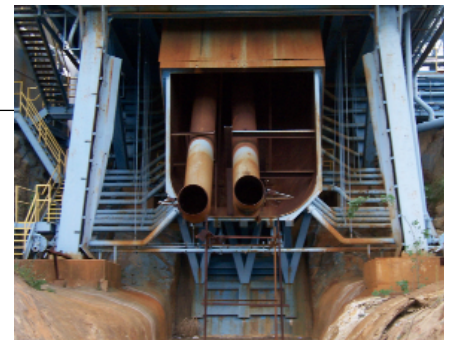
This Bravo test stand was used for test-firing engines with liquid fuel (kerosene). TCE was used to flush the engines before and after each test. This photo shows the bottom of the test stand.
